DRAFT REPORT

Dam Safety Assessment of CCW Impoundments

Possum Point Power Station

June 9, 2010

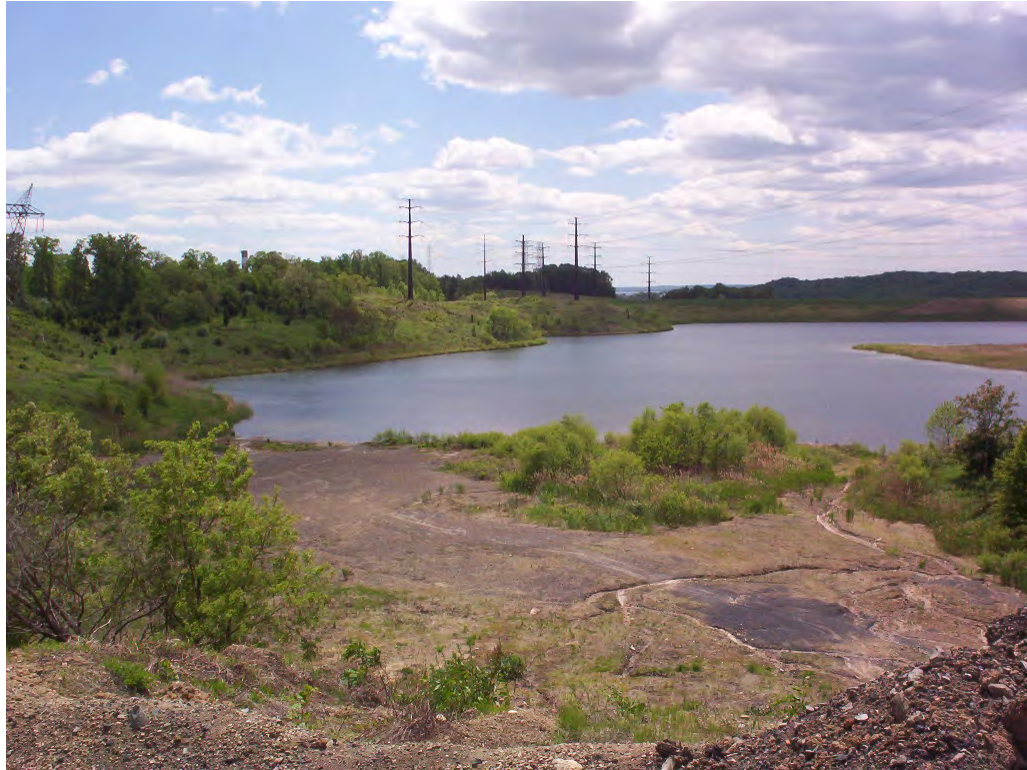
Photo Number:
1

Description:
Reservoir from
north bank.
Note dredged
material in
foreground of
picture

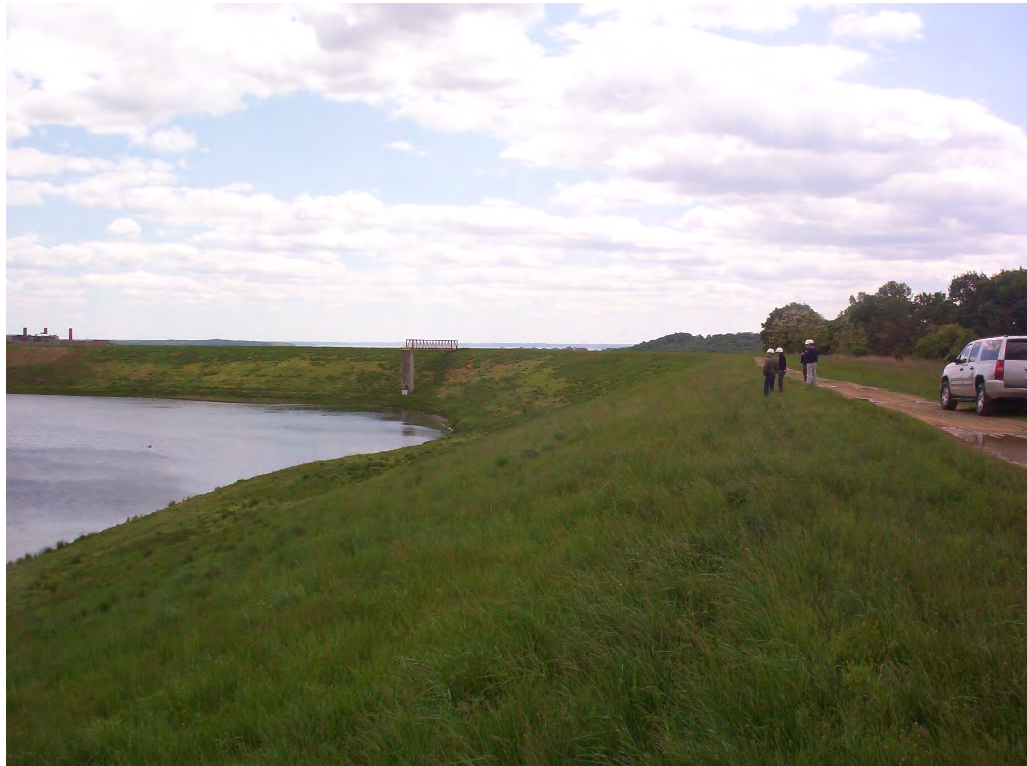
Photo Number:
2

- The upstream slope of the embankment is covered with well-tended grass, which is mowed 2-3 times per year (Appendix B – Photo 2 and 3).
- As noted in the review of the documents, Dominion Power personnel reported that a 24-inch thick clay liner had been installed on the upstream slope of the dam. Apparently, a large amount of rain fell last year and caused minor sloughing of the slope. Ongoing repairs have included regrading and hydroseeding of the slope. At the time of the site visit, the grass had not been reestablished on the slope. This area can be seen on the left side of Photo 3 (Appendix B).

Description:
Crest of dam
looking
upstream face.

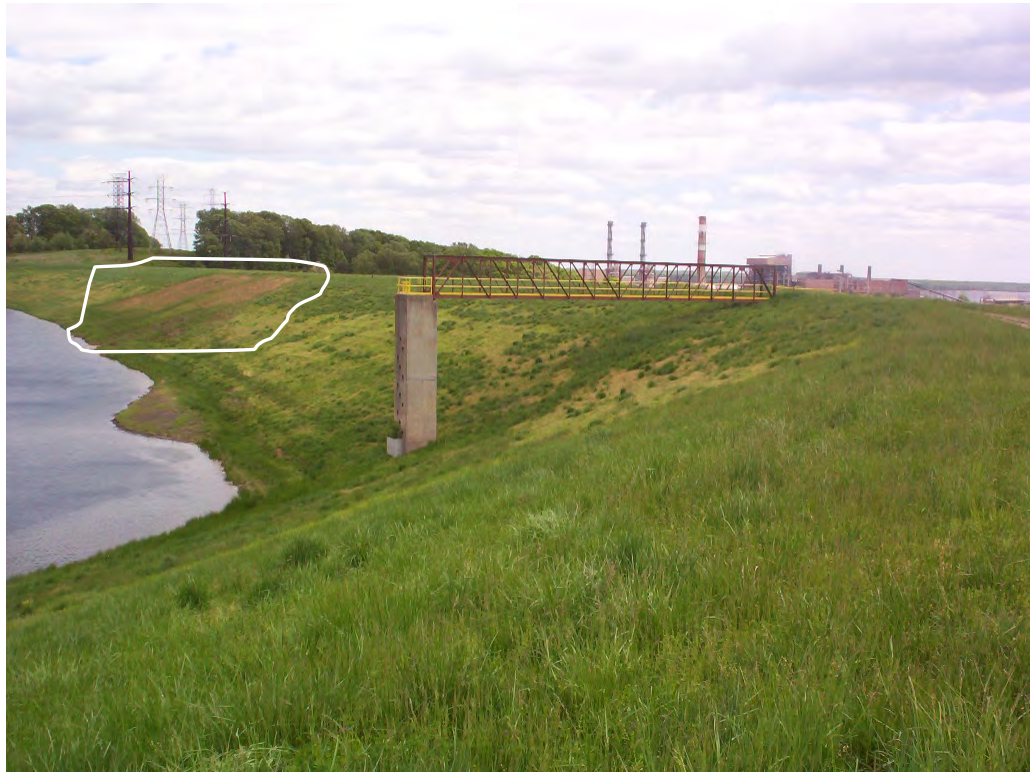
Upstream slope of dam and decant tower. Note area of bare soil toward middle of the dam which has recently been repaired due to sloughing of soil on top of clay layer.

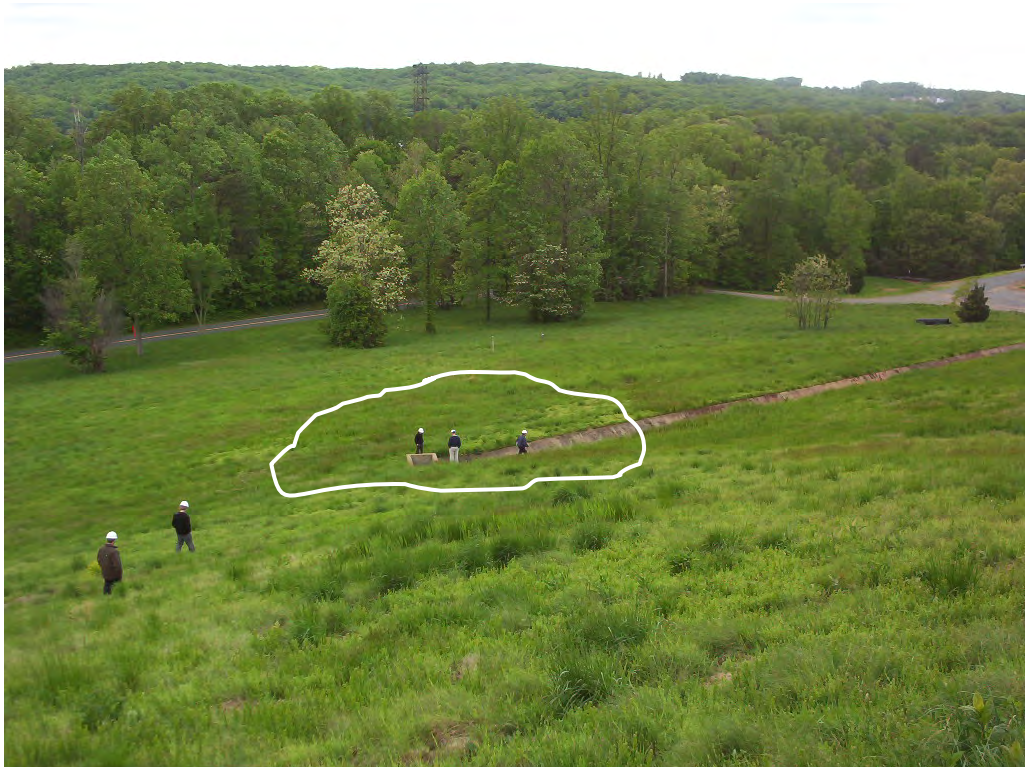
- On the downstream slope, there is an area of seepage along the southwestern portion of the embankment that appears to be below the pond water level. Dominion Power operators stated that this area is wet throughout the year, which results in difficulty in mowing because the tractors get stuck. Dominion Power also noted that this area was wet prior to the construction of the dam and it appears to be a perched groundwater condition at the interface between the embankment and natural ground. The area of saturation is shown by the taller grasses in Appendix B – Photo 4 and Photo 7.

Downstream slope of dam and drainage outfall structure and concrete channel. Approximate area of wetness highlighted.

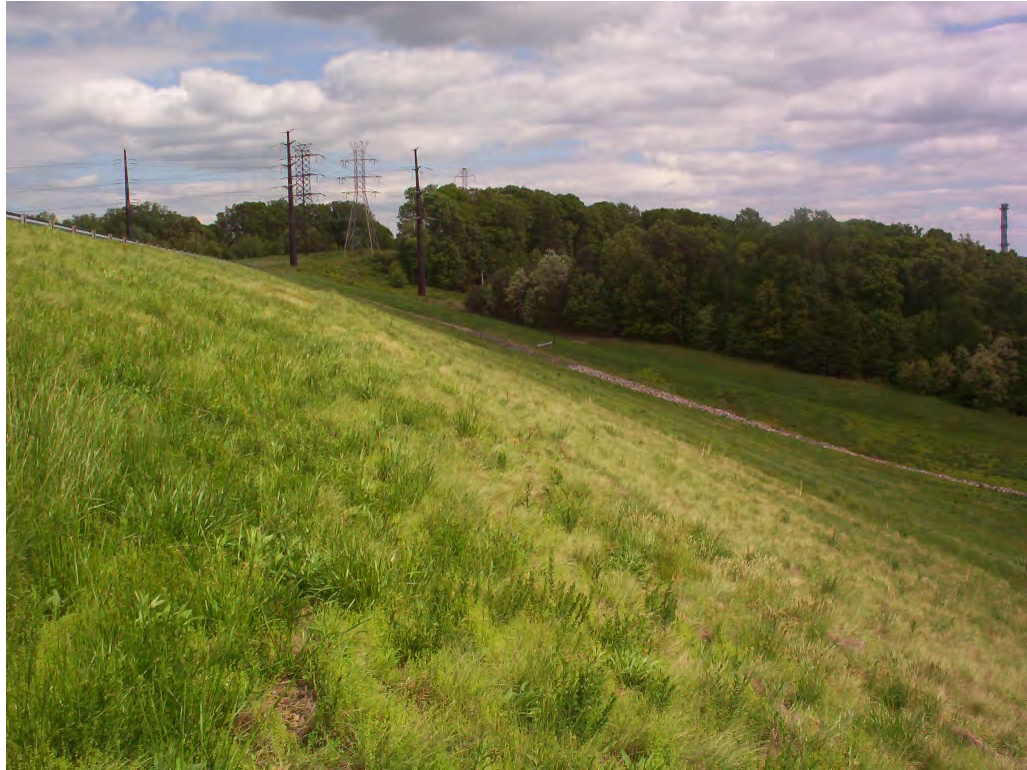
Photo Number:
5

- The downstream slope of the dam is well maintained, although there are some minor erosion gullies visible. (Appendix B – Photo 5). There are also several locations where sloughing occurred after construction. These areas have been repaired by filling with large riprap. A close examination of these areas showed no visible signs of continued movement.

Description:
Downstream
slope of dam.

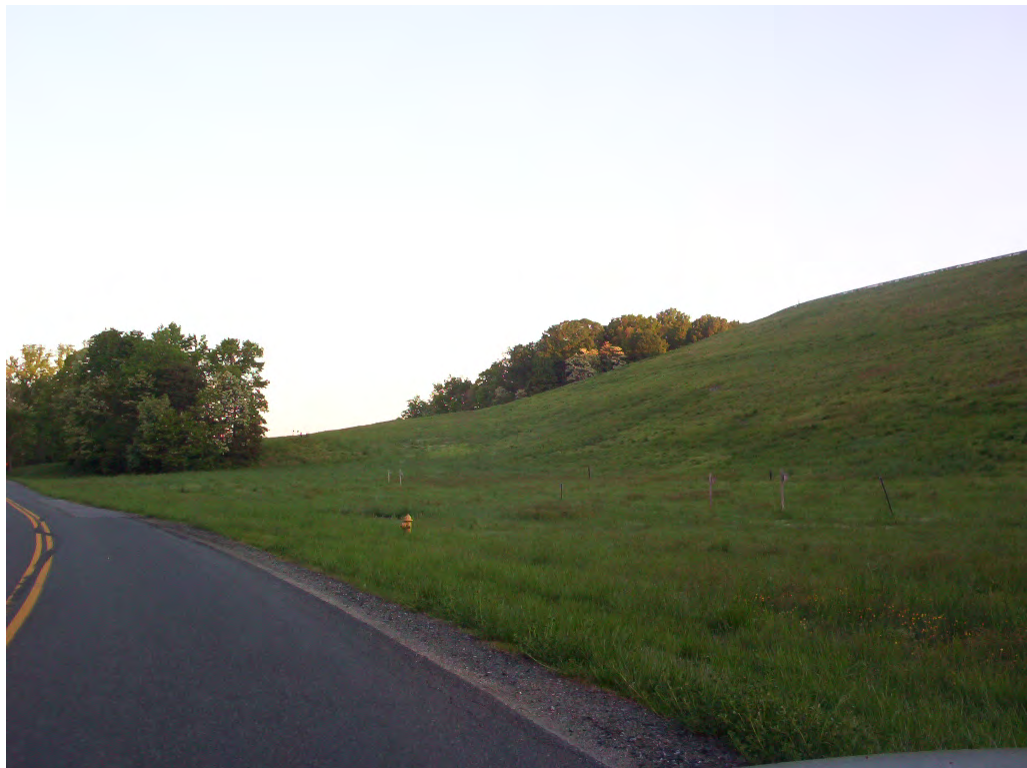
Photo Number:
6

Description:
Downstream
slope of dam.
Toe-drainage
structure near
fire-hydrant in
fore-ground

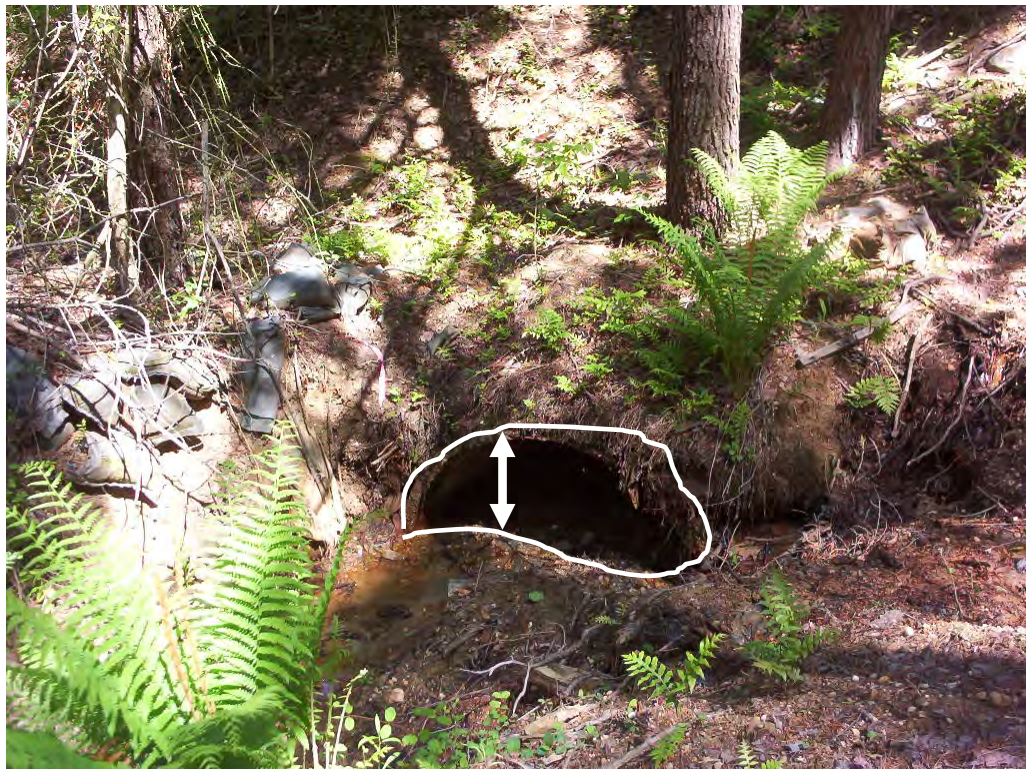
Toe-drain outlet pipe. Note, sediment in ditch only provide 2.25' opening in 6-foot pipe.

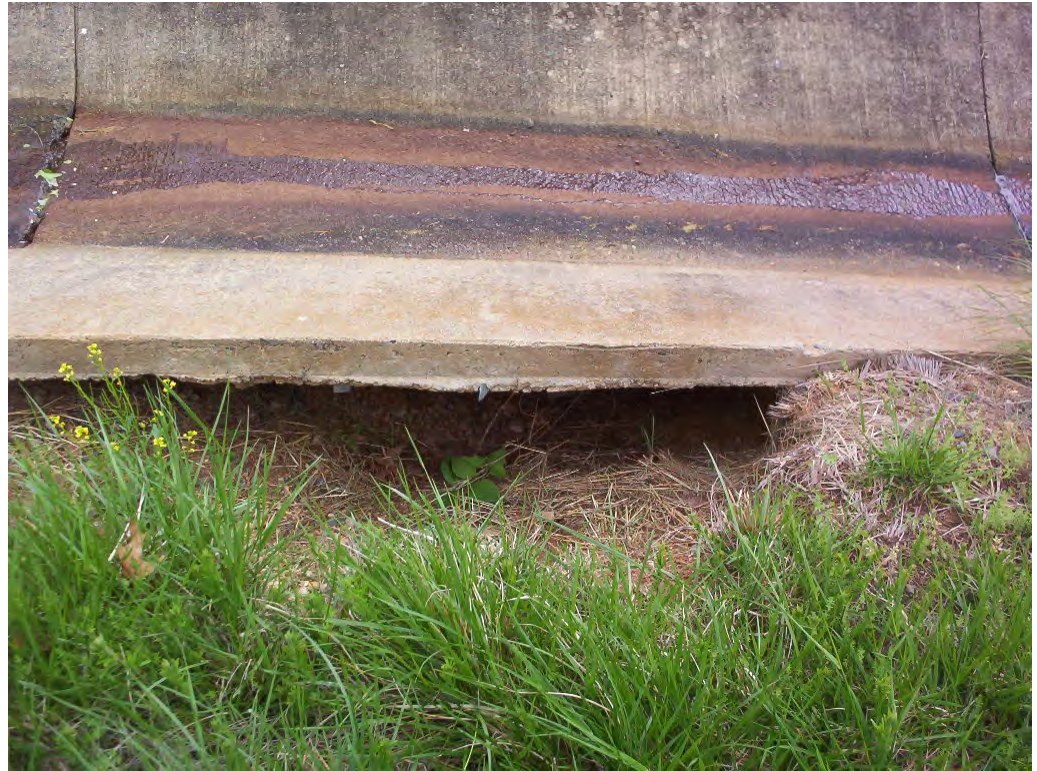
Photo Number:
9

Erosion at
downstream
concrete lined
channel from
Ash Pond D to
Ash Pond E

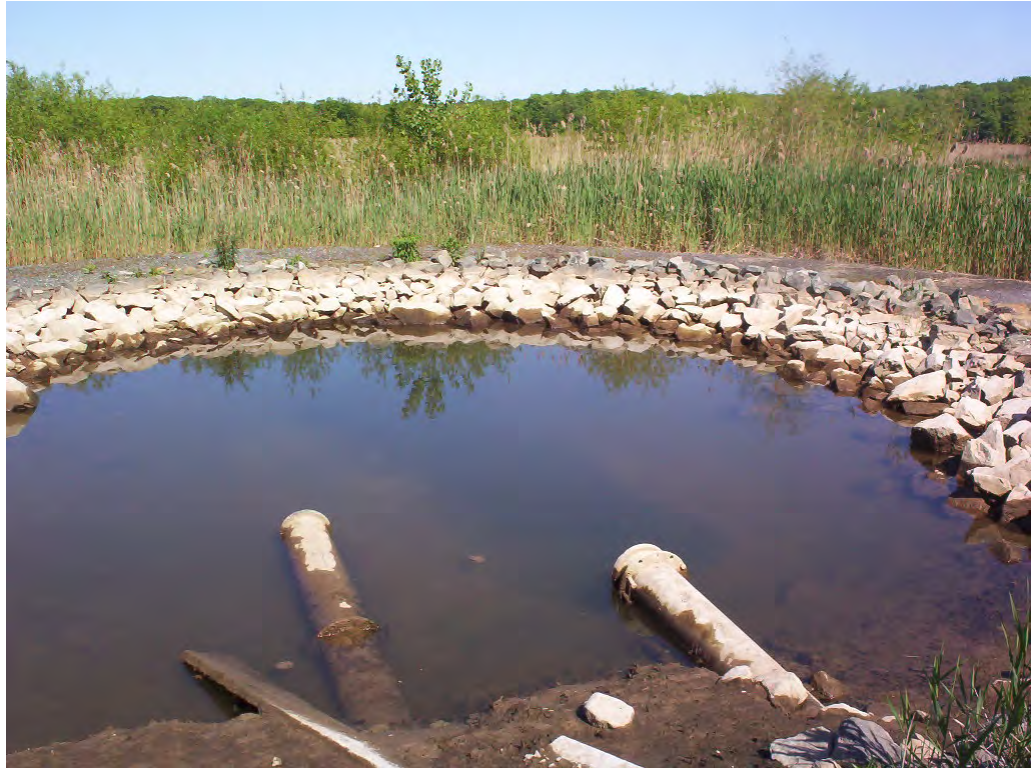
Photo Number:
1

Description:
Photo of stilling basin as pipes enter Ash Pond E

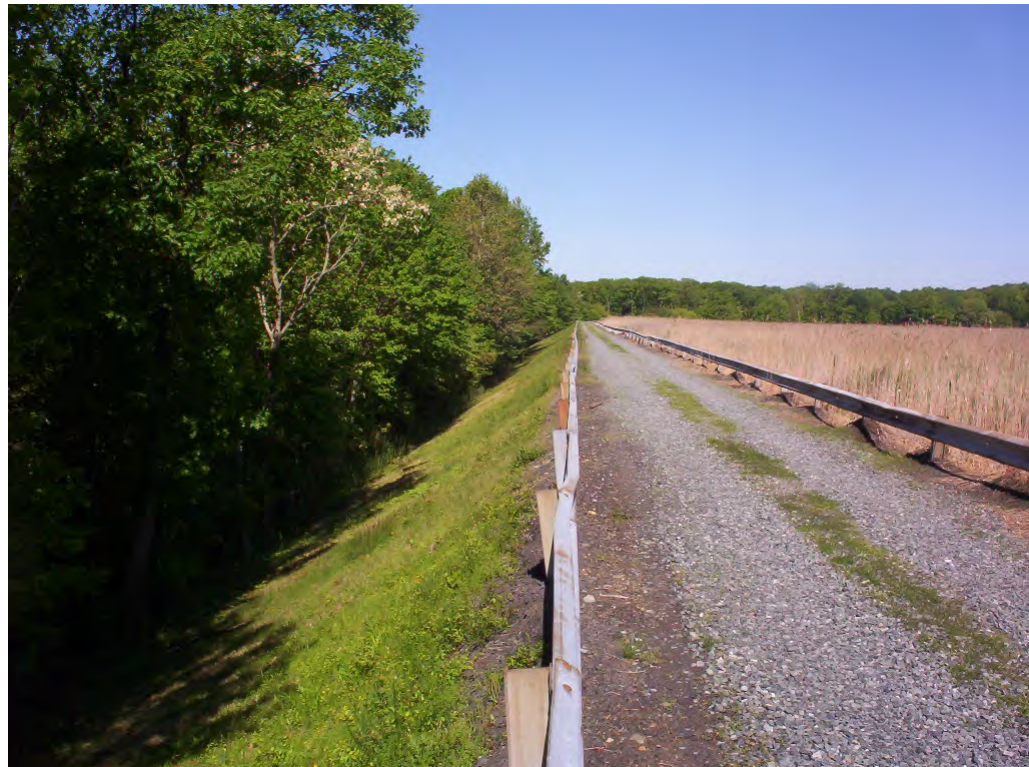
Photo Number:
2

Description:
Crest of dam looking West

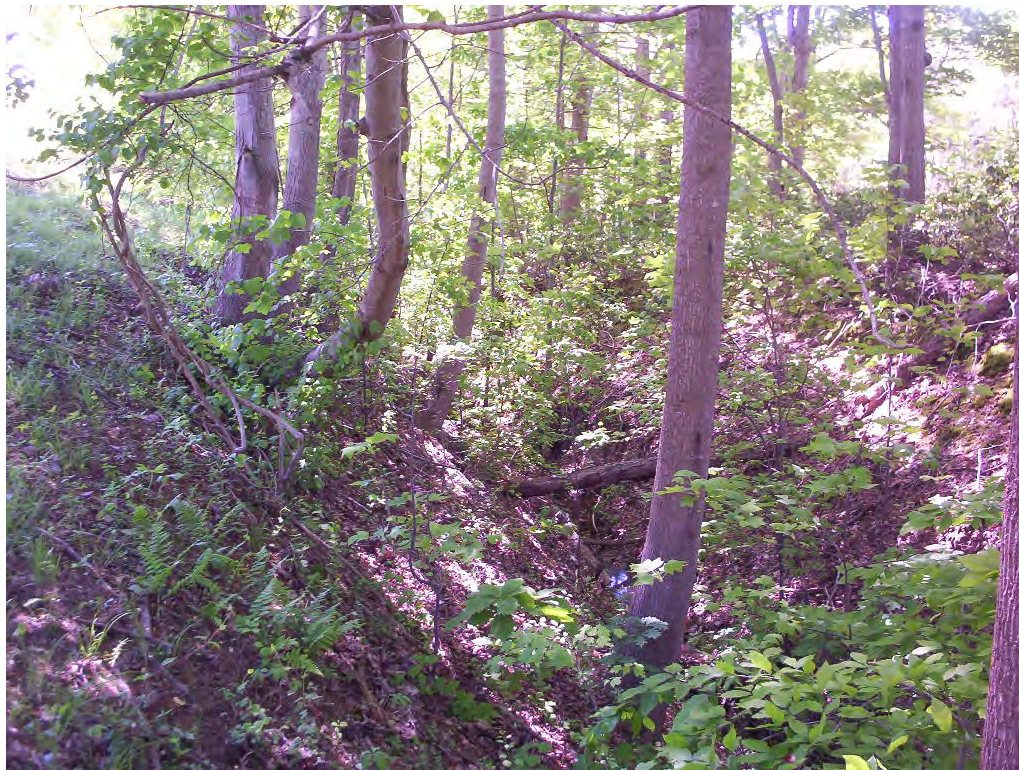
Deep ditch at
toe of slope

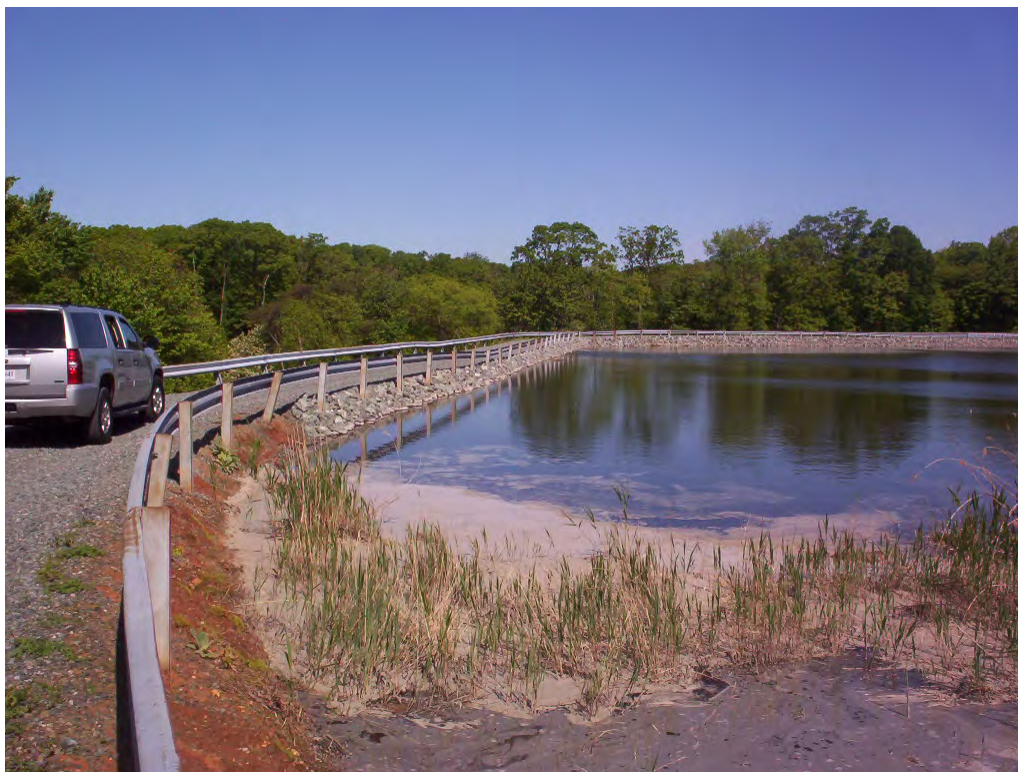
- The road appears to be in good condition; however, there appears to be some differential settlement along the crest of the dam (Appendix C – Photo 4). The actual crest elevation could not be established from the site visit or the records, but it appears to vary by as much as 2 feet. The elevation difference can be seen if Photo 10 and Photo 4 are compared. Survey elevations were not obtained during the site inspection, but at the southwestern corner of the impoundment, the apparent difference between the water surface elevation and the crest of the dam was less than three feet.

View along
crest of
dam/upstream
side. Note
cenospheres in
foreground and
accumulated
CCW

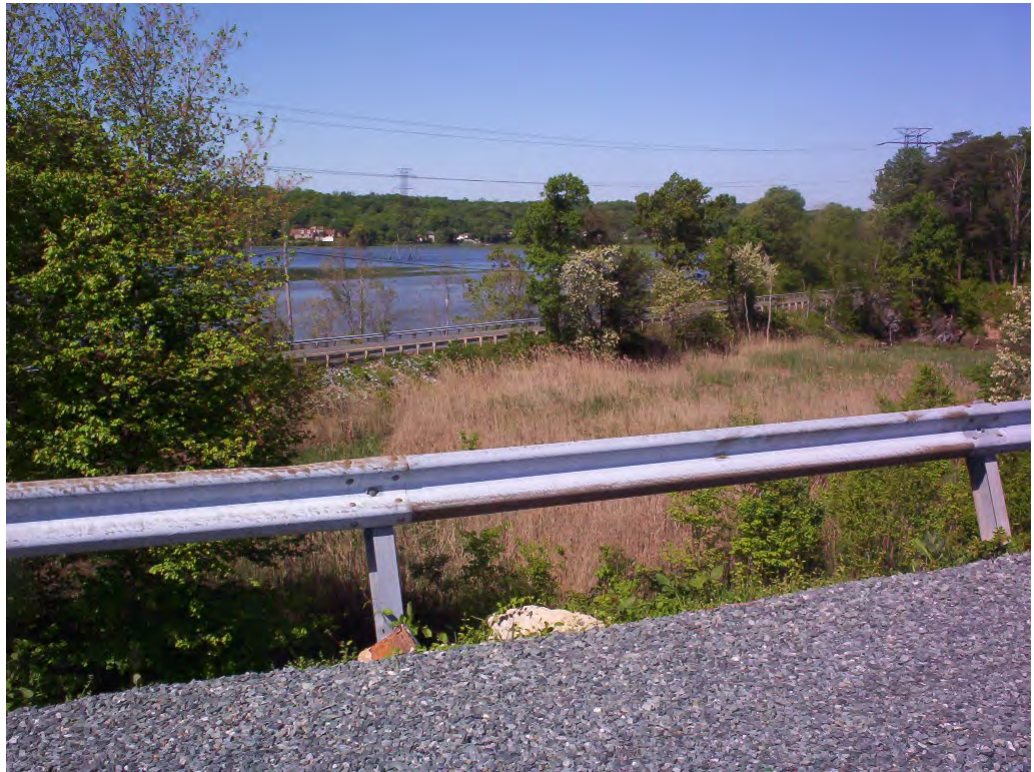
Photo Number:
5

Looking at
marsh area
downstream of
dam and close
proximity to
Quantico Creek
(bay).

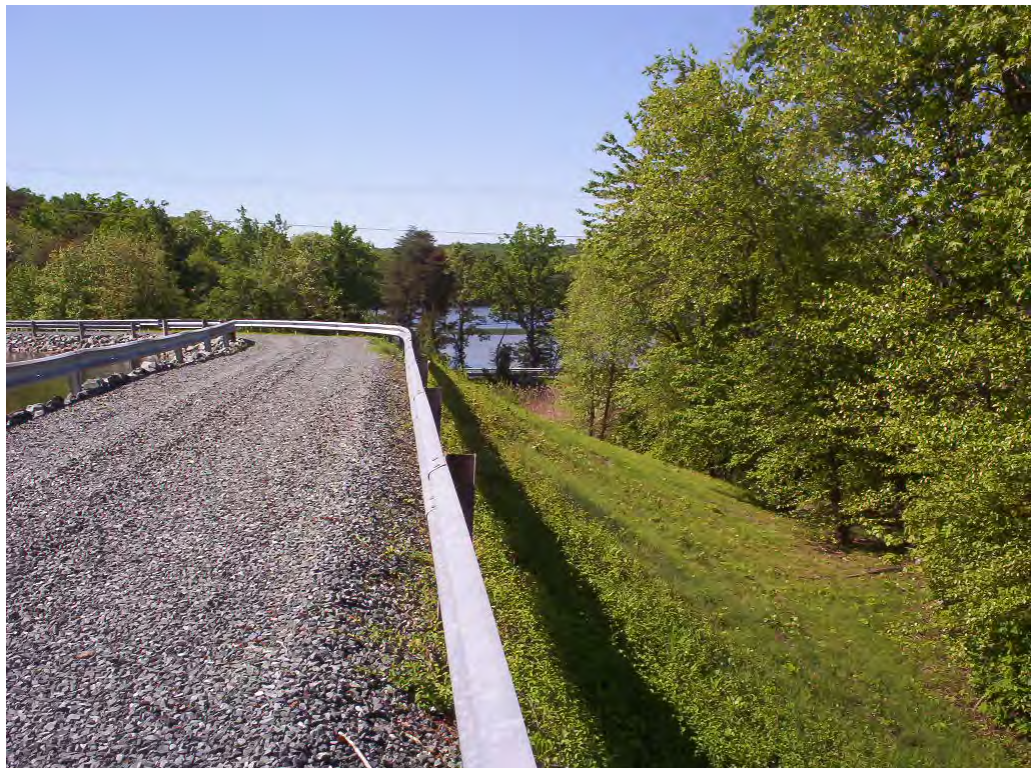
Photo Number:
6

Description:
Crest of dam
looking at
downstream
slope. Notice
trees
encroaching on
toe of dam.

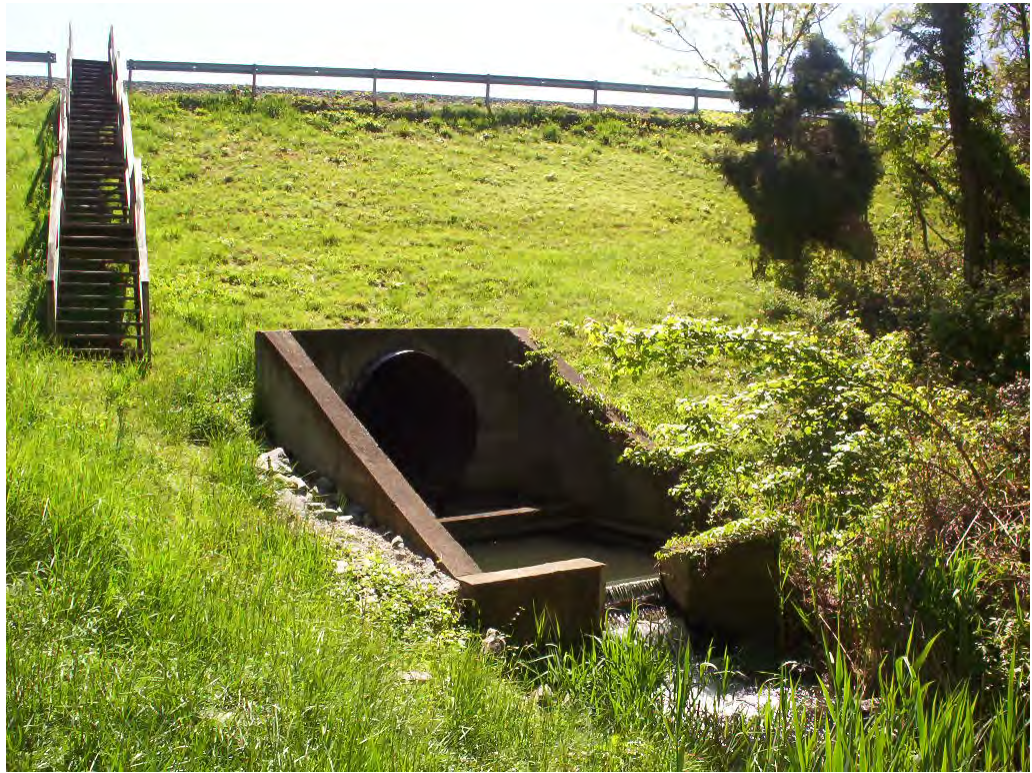
Photo Number:
7

- The outlet structure appeared to be in good condition and functioning normally (Appendix C – Photo 7 and Photo 8). However, the operators adjust the pond elevation by inserting or removing stop logs at the spillway drop inlet and it could not be determined if there is adequate freeboard between the maximum pool elevation and the low point on the crest of the embankment.

Description:
Outfall
Structure.
Steps on left
provide access
from the crest
of the dam.
Monthly VPDES
samples are
collected at this
location.

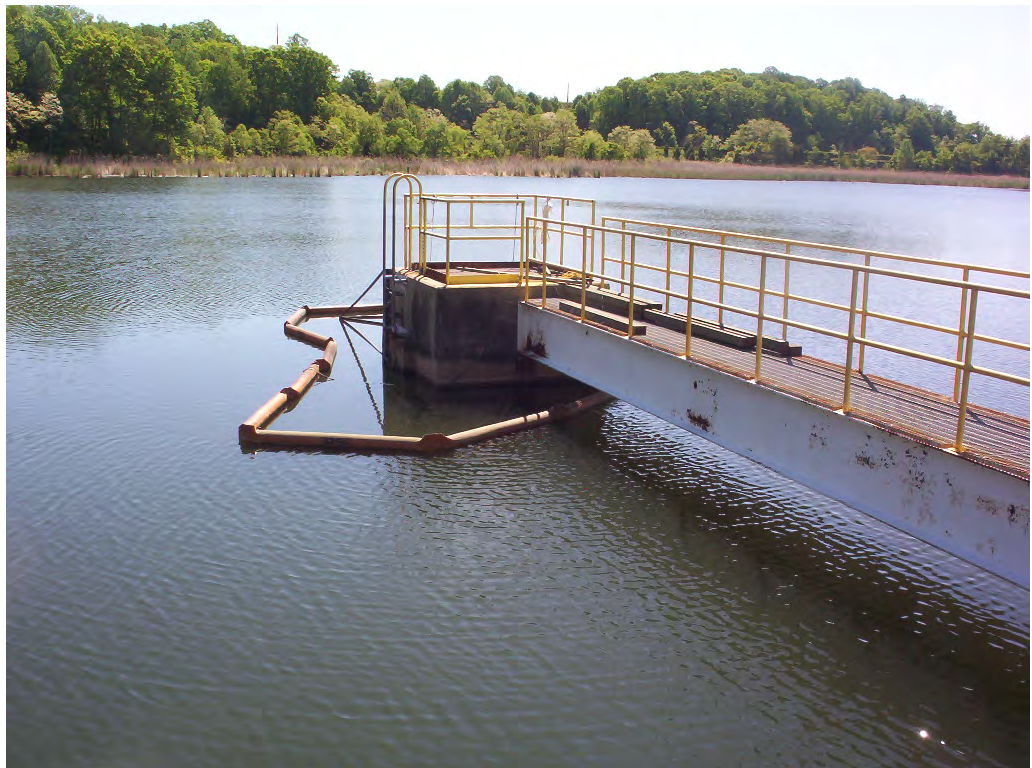
Photo Number:
8

Description:
Decant
structure. Note
boom on
surface to
prevent
floatables from
entering
discharge pipe.

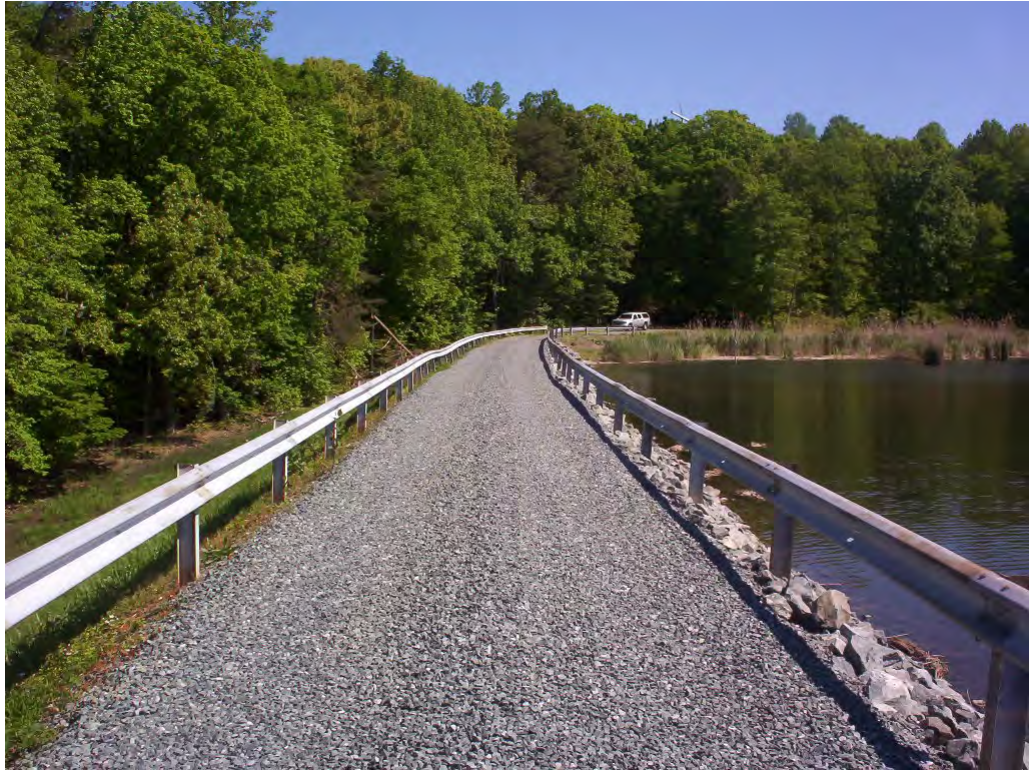
Photo Number:
9

Description:
Crest of dam.
Noted gravel
driving surface
and rip-rap on
upstream face
of dam.

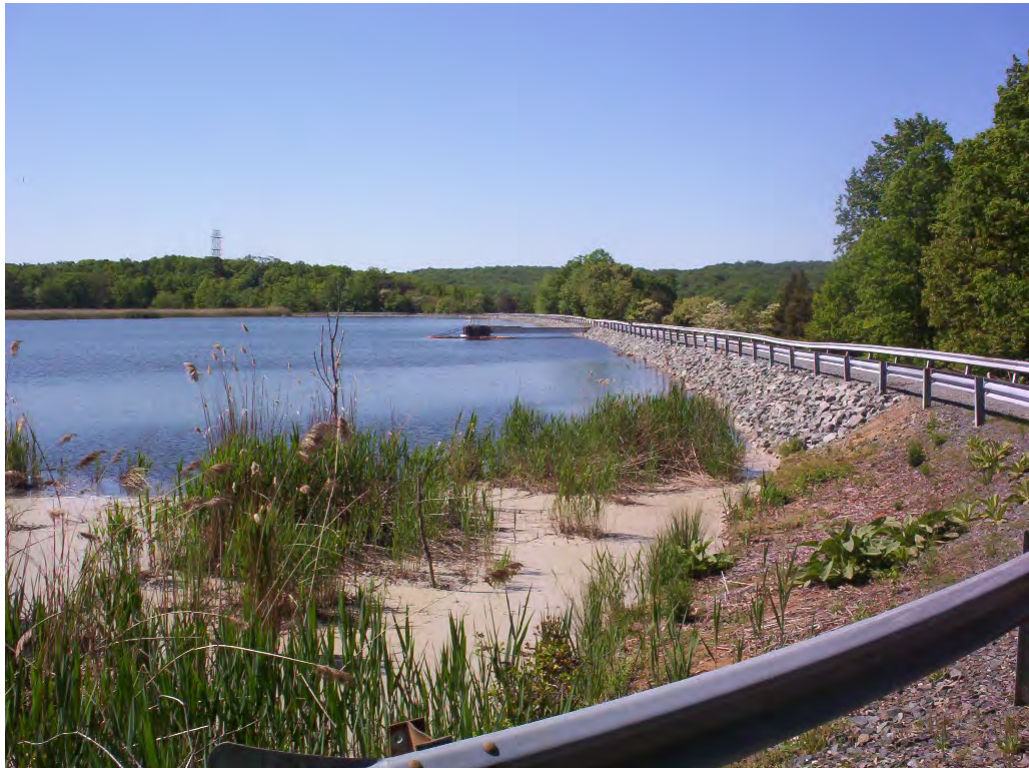
Photo Number:
10

Description:
Upstream face
of dam.
